Geometrical and geotechnical characterization of the earth fissures appeared in the Guadalentín Valley (southeastern Spain) after the September 2012 flooding

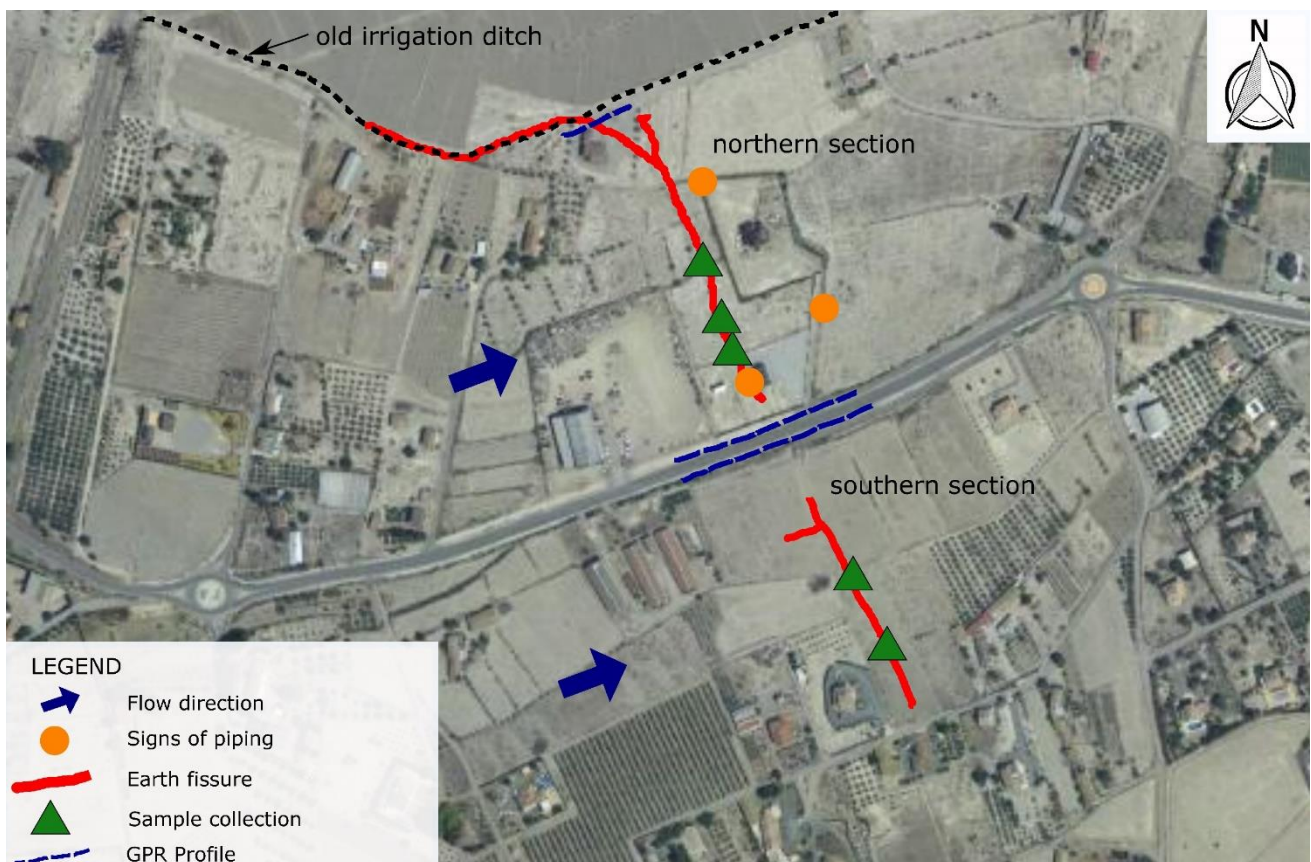
Figure 1: Location of the Puerto Lumbreras earth fissure and the location of signs of piping and samples collection. Modified from Mulas (2013). Derivative work from PNOA 2019 CC-BY scene.es.

The mapping of the Puerto Lumbreras earth fissure is shown in Figure 1, modified from Mulas (2013). This figure shows the distribution of the fissure that appeared when waters receded on a very flat land. The main crack was about 400 m long and was perpendicular to the main flow of the flood, except for the northern section of the crack where it was nearly parallel to the flow. The crack presented a main NW-SE orientation (N150E) that changes to E-W in the northern section.

It is important to point out that the continuity of the earth fissure was disrupted by the road located at the center of the figure which presents a lower elevation. The orange points in Figure 1 indicate those locations in which signs

of piping were recognized in the field (Figure 2) and the green triangles indicate the locations from which soil samples were collected to be tested later in the laboratory. During the field inspection, a damaged ditch was observed beside the aforementioned road after the flooding. This road was approximately parallel to the main flow of the flood and some erosion was clearly observed below the ditch.

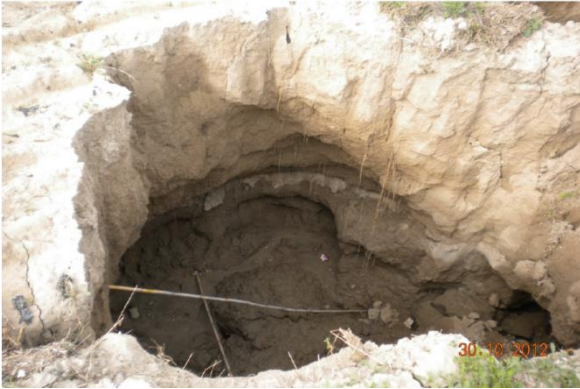
Figure 2: Signs of piping along the fissure. Soil erosion caused by water beneath the surface of the ground creating an underground tunnel.

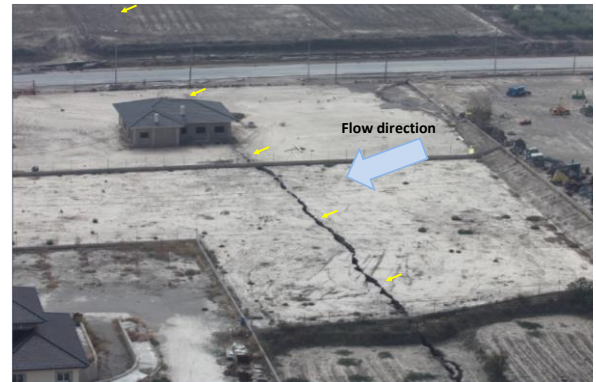
A GPR was used along the ditch beside the road to analyze what was beneath the concrete (Figure 3). The contact between the natural soil and the filling is observed in this figure. A water pipe was also detected, as well as some loss of signal that can be due to soil erosion. However, no good information was obtained below 1.5 to 2.0 m, probably due to the silty clay composition of the soil. Figure 4 shows an aerial view of the northern section of the crack and the runoff flow direction. Note how the fissure intersects and surrounds the building. Figure 5 shows the location in

Figure 4: Aerial view of the northern section of the crack (courtesy of Puerto Lumbreras City Council). The yellow arrows indicate the location of the earth fissure. Modified from Mulas (2013).

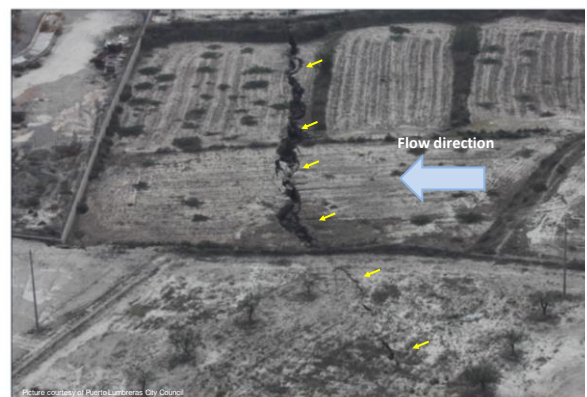
which the direction of the fissure changed from NE-SW to E-W. The aperture of the fissure can be seen in this figure. The fissure showed rough and vertical sides with a maximum depth of 3.7 m and a maximum aperture of 2.7 m.

Figure 5: Aerial view of the 3rd and 2nd northern section of the crack (courtesy of Puerto Lumbreras City Council). The yellow arrows indicate the location of the earth fissure. Modified from Mulas (2013).

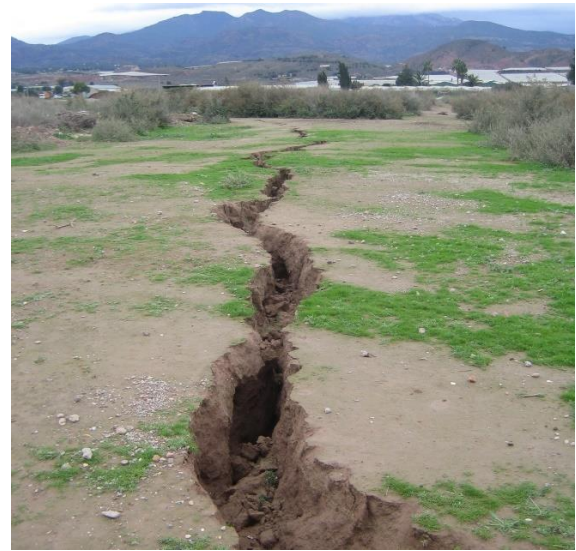
Regarding the Totana earth fissure, the location and distribution of the fissure observed when water receded can be seen in Figure. Figure shows a view of the fissured appeared in Totana. The fissure appeared on a flat land and

was discontinuous and ramified. Both soils, in Totana and Puerto Lumbreras, have a similar origin, a distal alluvial fan, although the age of the soils in Totana is older than in Puerto Lumbreras, Late or Upper Pleistocene (more than 10,000 years ago) in Totana and Holocene (less than 10,000 years ago) in Puerto Lumbreras. Some signs of piping were also observed in this fissure and one sample was collected at the site to test it later in the laboratory. The results of the tests show sand, silt and clay of 25, 53 and 22%, respectively. The liquid limit was 31.8 and the plasticity index 8.3. Therefore, the soil was classified as a low plasticity silt (ML) according to the USCS. The results to assess the soil dispersion (Crumb, Double Hydrometer and Pinhole tests) showed a non-dispersive soil.

Figure 7: Image of the fissure appeared in Totana.

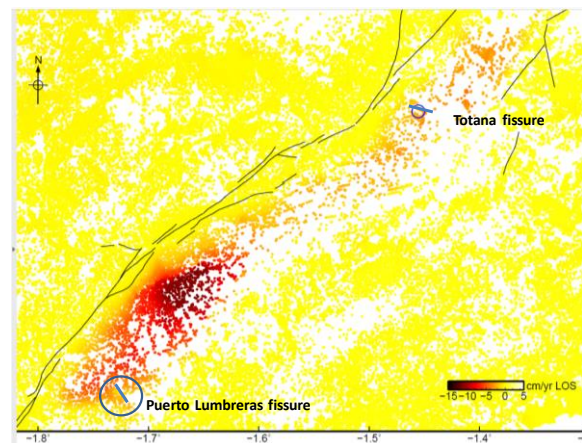
Figure 8: Location of both fissures on the deformation map of Guadalentín Valley from Envisat 2003-2010.

Figure shows an SAR interferometry deformation map derived from an Envisat dataset covering the period 2003 – 2010, where the location and main direction of the fissures have been drawn. As can be seen, both fissures are located near the edge of the subsidence bowl. It is worthy to point out that this valley presents the highest subsidence rate due to groundwater extraction in Europe with accumulated settlements up to 2,5 m from 1992 to 2012 (Bonì et al., 2015).

The direction of one of the main geological structures of the Guadalentín Valley can be seen in Figure 8. The other main direction is perpendicular to the first one (Cerón, 1997). Therefore, the direction of both fissures are

approximately parallel to one of the directions of these main geological structures or faults in this area.
