## SINT SEBASTIAANSBRUG, DELFT. REUSE REQUIRES CREATIVE THINKING

Rodriaan Spruit, City of Rotterdam Engineering, Rotterdam, Netherlands, r.spruit@rotterdam.nl  
Albert Allaart, City of Rotterdam Engineering, Rotterdam, Netherlands, ap.allaart@rotterdam.nl  
Hans Pacejka, City of Rotterdam Engineering, Rotterdam, Netherlands, he.pacejka@rotterdam.nl  
Suzanne J.M. van Eekelen, Deltares, Delft, Netherlands, suzanne.vaneekelen@deltares.nl

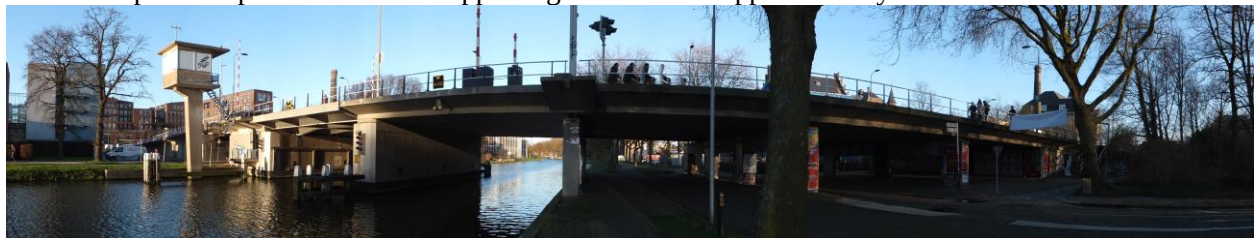
Fig. 1. Panoramic overview of the old bridge

The Saint Sebastian bridge in Delft was built in 1964. The bridge crosses the Delftse Schie with a fixed span of 12 m and a movable span of 12 m. In the middle of the waterway, both the fixed and movable bridge decks rest on a pier. The vertical clearance of the fixed part is 4.5 m. On both banks there was an approximately 80 m long access ramp, consisting of a concrete construction on piles. Each section of the access ramp had a span between the supporting structures of approximately 10 m.

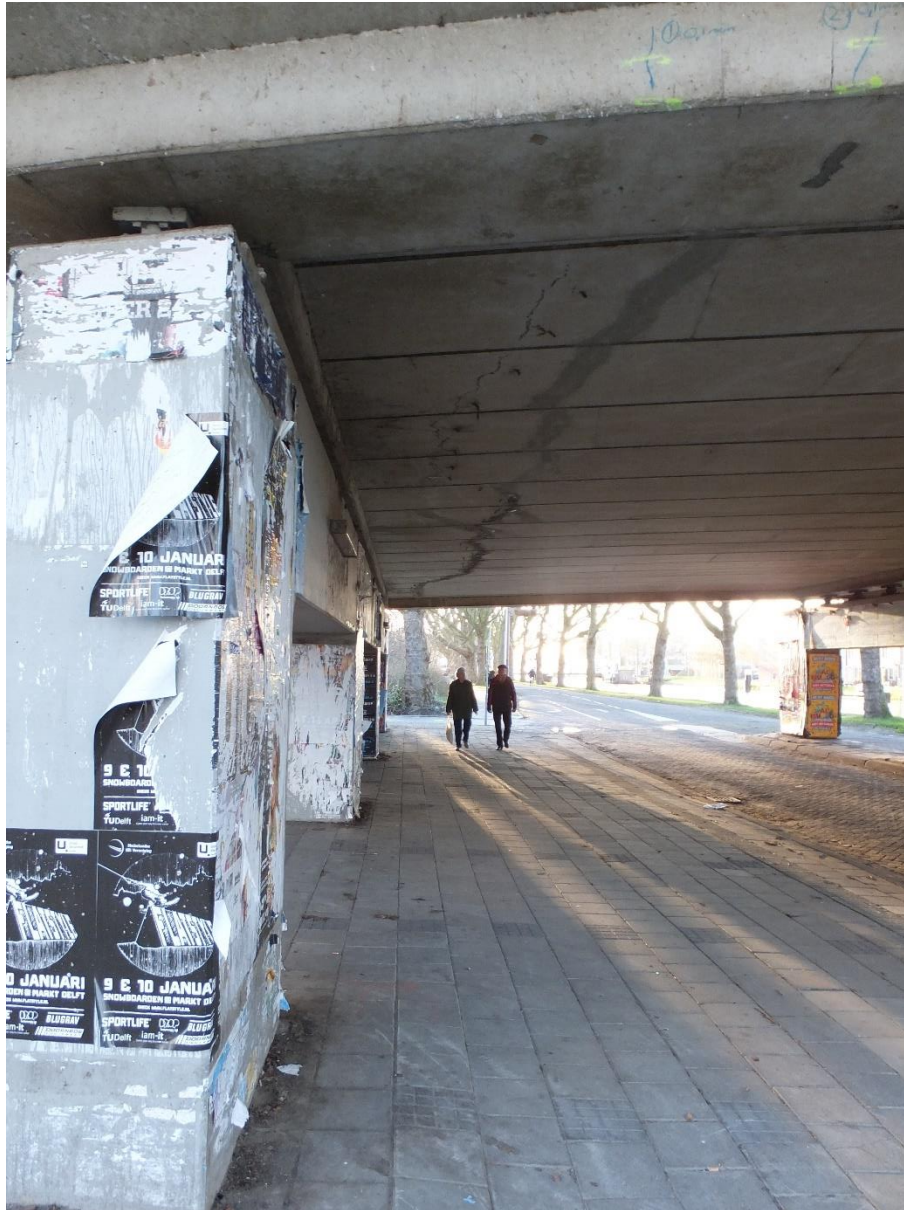
Fig. 2. Example of cracks in the concrete

During the preparations for converting the bridge to accommodate a tram in 2006, a thorough inspection of the bridge was executed. The inspection conclusions were very unfavourable. Several supporting structures had settled considerably, causing structural damage to the upper structure (Fig. 2).

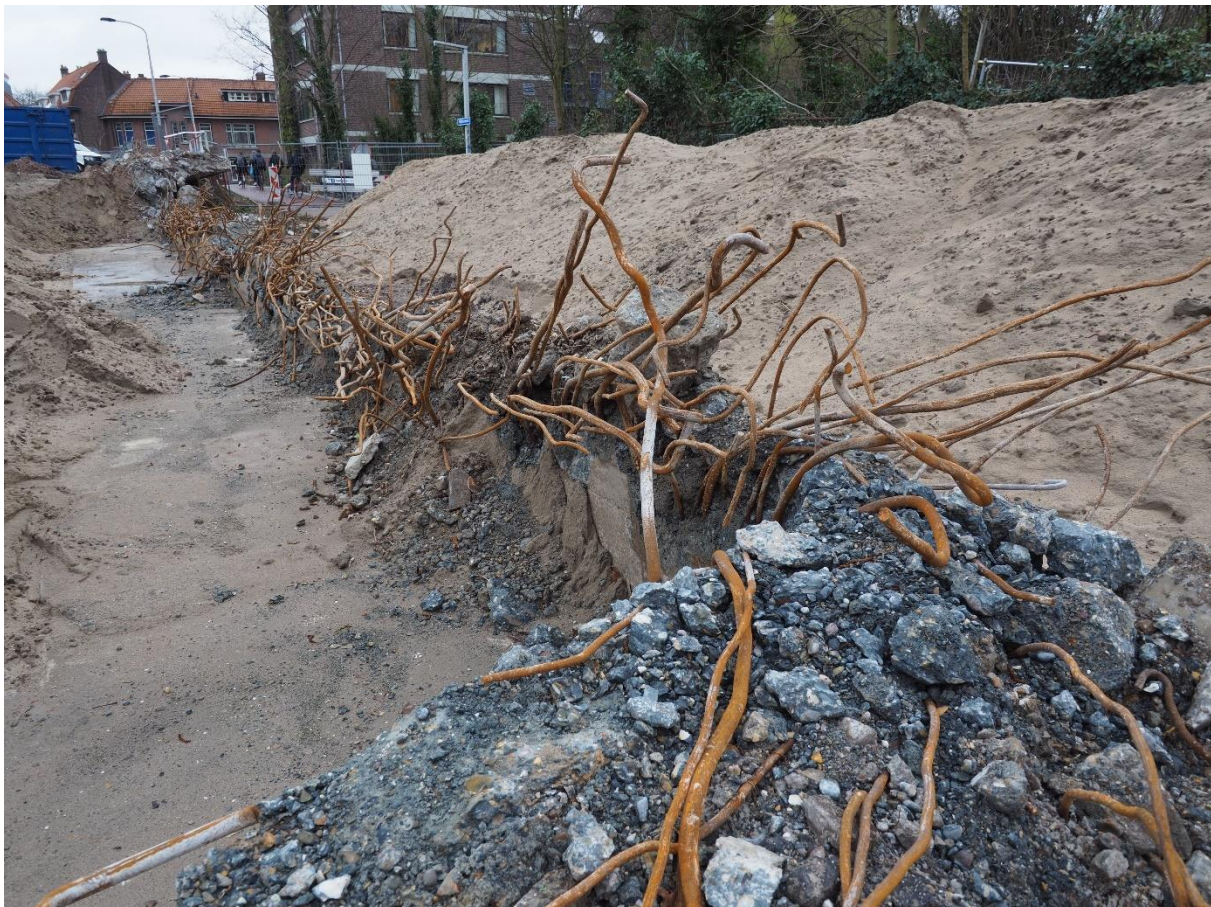
**Fig. 3. Demolished access ramp on the south bank**

The concrete structure ramps on both sides of the channel were expensive to replace as well. One of the reasons for these high costs was the foundation pile type that was used to build the original ramps. These precast concrete piles had a toe with an extended diameter, to increase the pile bearing capacity. These wide pile toes had two disadvantages:

- The maximum pile-driving load was limited due to the relatively narrow pile shaft. Therefore, the contractor in 1964 was not able to install the pile sufficiently deep. This resulted in a lower bearing capacity than planned, and ultimately caused the damage to the bridge.
- The removal of the extended-toe-diameter piles is relative difficult, if not impossible. The relatively narrow pile shaft here again limits the pulling force that can be applied, and the wide foot acts as a kind of anchor. This gives high costs for the removal, and pieces will remain in the soil, giving hindrance for the installation of the new piles.

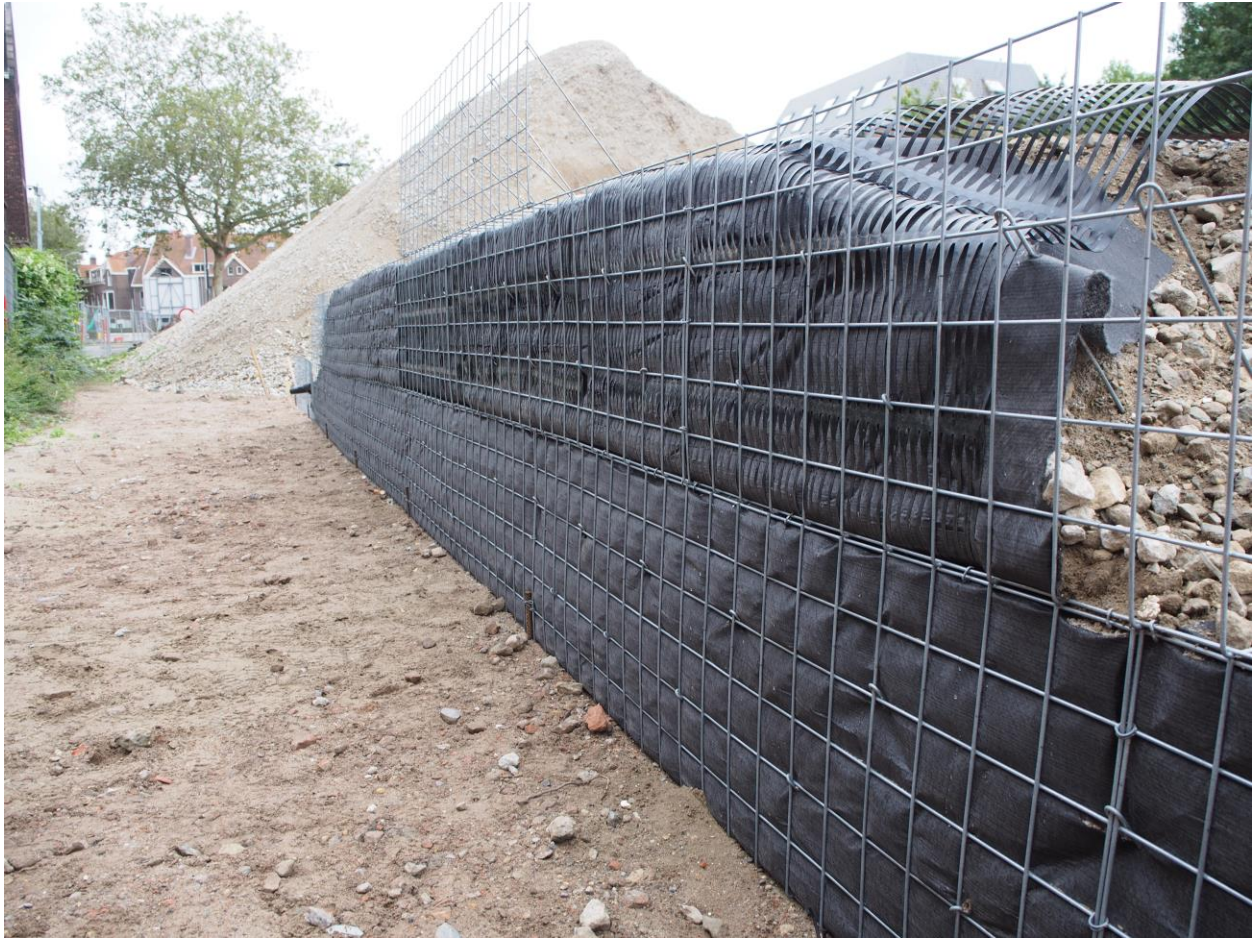
**Fig. 6. Temporary support of the vertical slope**

The installation of the geogrids of the vertical slopes along the sides of the access ramps was executed without using a temporary support mould. The contractor used a system consisting of metal grids with internal stability (see Fig. 6).

Although installing the 45 degree tension bars through the geosynthetics was cumbersome, in the end the system worked well enough. It took however much more effort to make a more or less straight vertical wall using this system than with a temporary support wall.

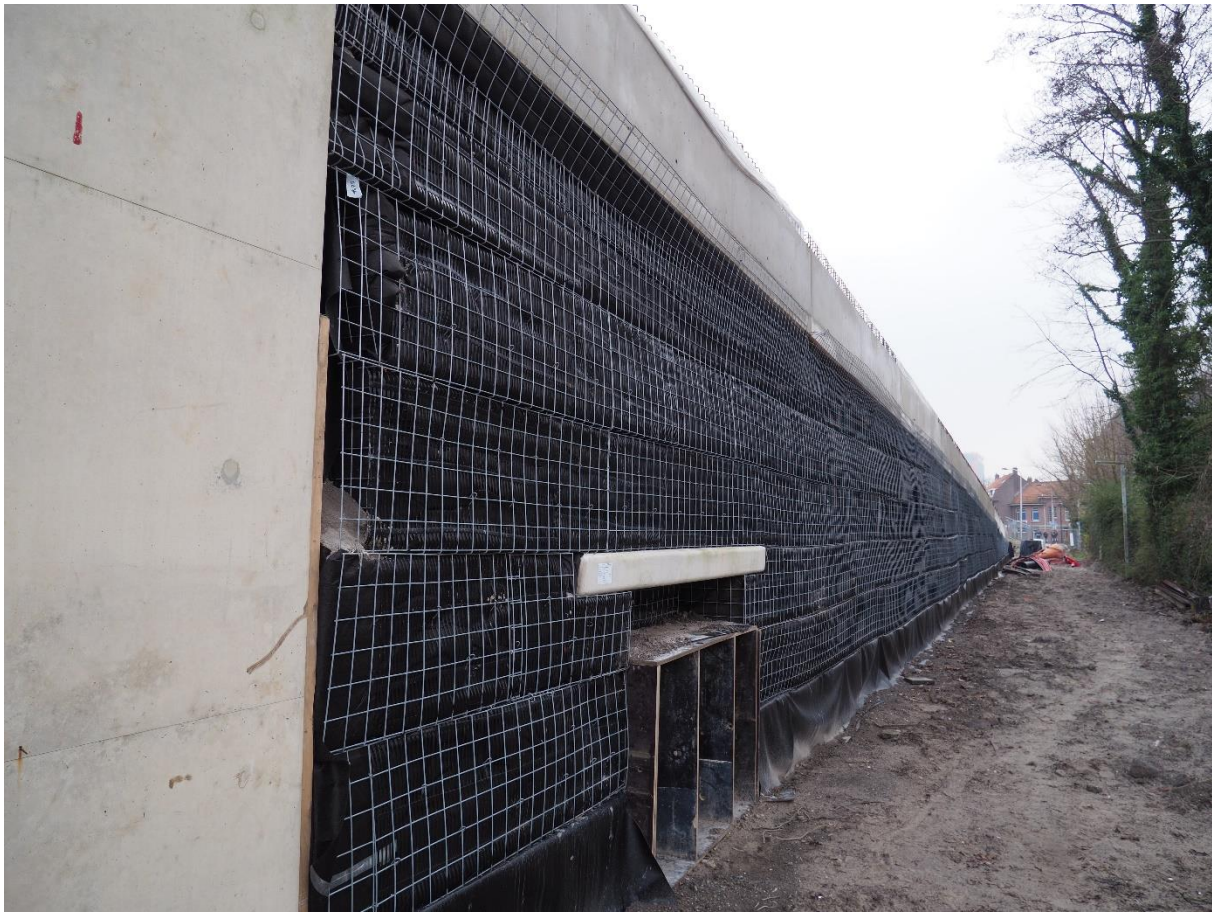
**Fig. 7. Vertical slope south bank, west side (not perfect but acceptable)**

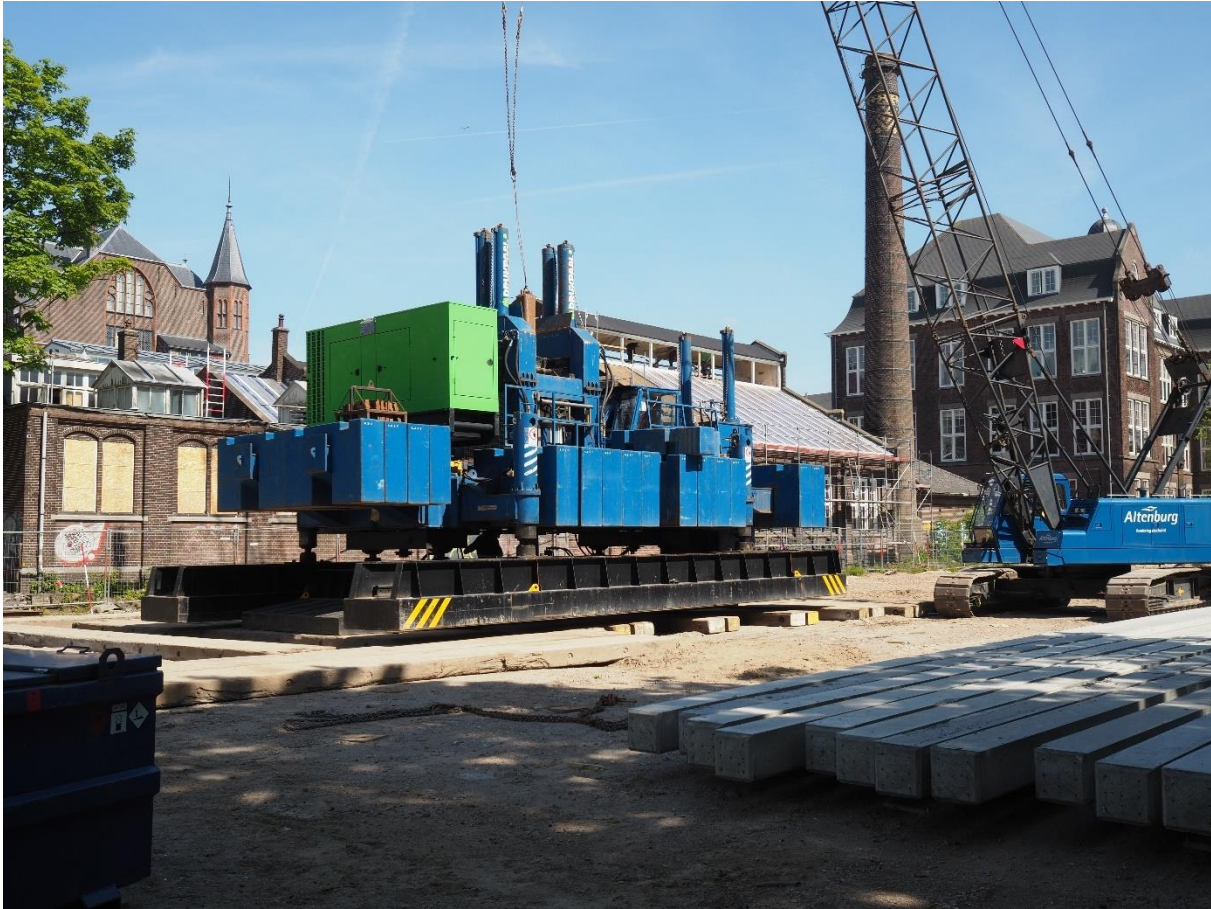
**Fig. 8. Pile Pusher Pro (drukpaal.nl) piling rig**

In the original plan, all piles within 20 m of surrounding buildings were planned to be screw-injection (vibration-less) piles. All other piles were planned to be driven prefabricated concrete piles. However, the contractor proposed to install only prefabricated concrete piles with a push-in piling rig. The proposal of the contractor was accepted because it had also been considered in the design stage. At that time, it was only rejected due to the monopoly position in the Netherlands of the push-in piling company.

Piling with the pile-pusher (drukpaal.nl) generally worked well, but many obstacles in the soil were encountered. As a result, piling took more time than planned, but this would have been the case as well with regular pile driving. A significant advantage of the pile-pusher system is the continuous registration of the exerted penetration force. Each pile is documented with a CPT-like diagram. Failing piles could be recognised easily. Piles that did not reach the final depth could be evaluated quite easily for use in the construction because the push-in force is a good indication for the bearing capacity.

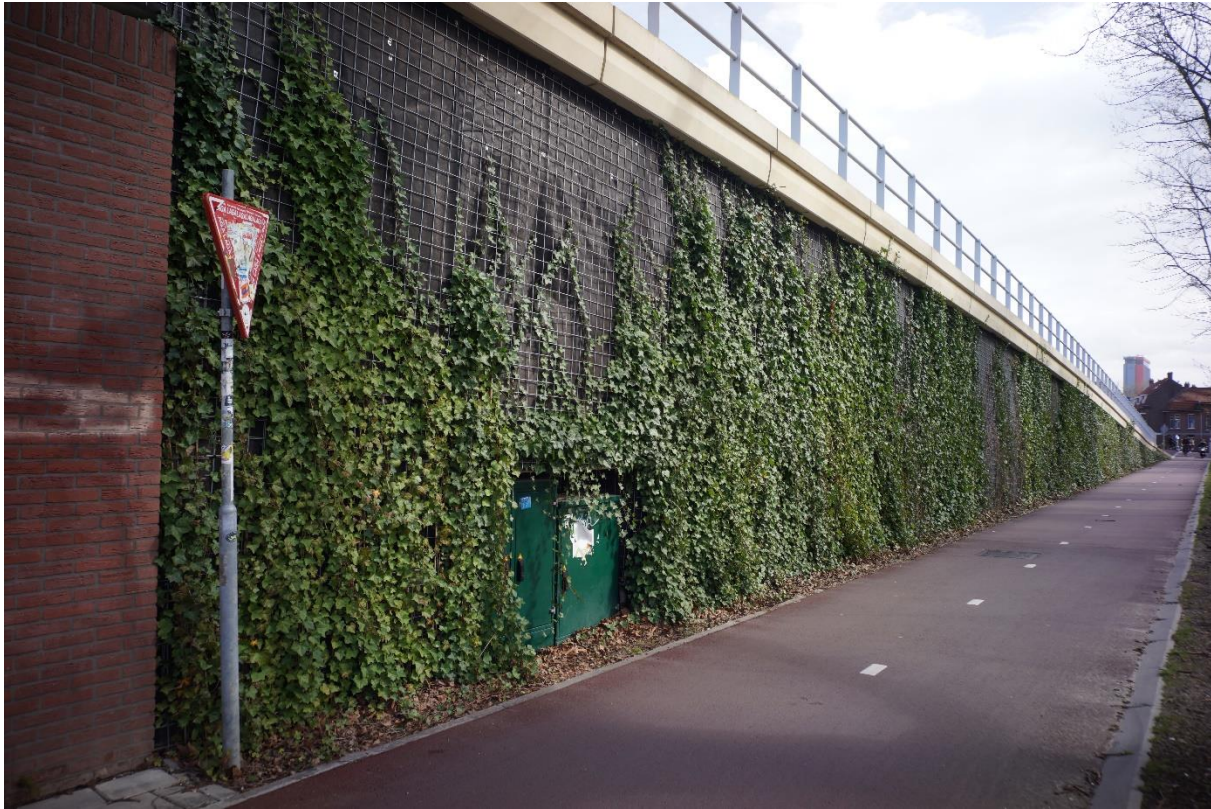
**Fig. 9. Access ramp south bank (west side) final result**
